Proceedings of AIPnD **art**'23
*14th International Conference on non-destructive investigations and microanalysis
for the diagnostics and conservation of cultural and environmental heritage*
Brescia (Italy) - 2023, November 28th/30th

edited by
Monica Volinia, Antonello Tamburrino

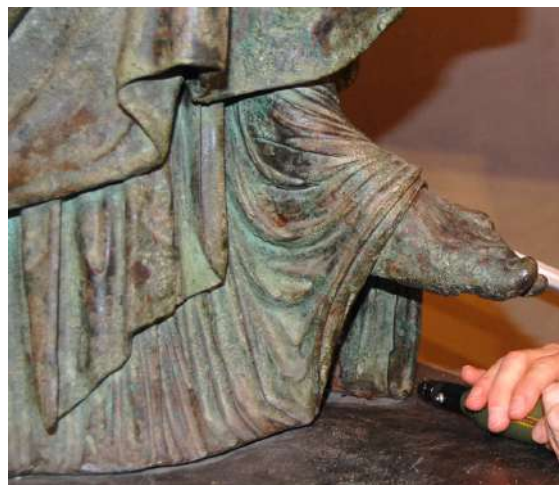
Fig. 3 Taking samples of the alloy with a drilling tip for the analysis of the alloy composition.

used for thermoluminescence dating. The outcome of the measurements shows that the baking of the casting core occurred between 30 and 290 A.D., a timespan that confirms the attribution of the statue to the Roman period rather than to the Greek one [2]. From the mineralogical and diffractometric analyses, the composition of the sandy fraction of the core appears compatible with the soil outcropping in the hills North and East of Brescia, suggesting the possible realization of the statue in a workshop in the city area [10]. The composition of the alloy is another relevant element in addressing the construction phases of the *Vittoria*. Since the presence of corrosion layers may bias quantitative elemental data provided by the application of non-invasive techniques, we have chosen a micro-invasive and multi-technique approach to ensure the reaching of the sound metal and therefore to come to a reliable result on the alloy composition. We combined scanning electron microscopy (SEM) coupled with X-ray microprobe and Time-of-Flight Neutron Diffraction (ToF-ND) to study micro-fragments, and portable X-Ray Fluorescence and Inductively Coupled Plasma-Mass Spectrometry to analyze shavings drilled with tips of less than 1 mm diameter [10, 11] (Fig. 3).

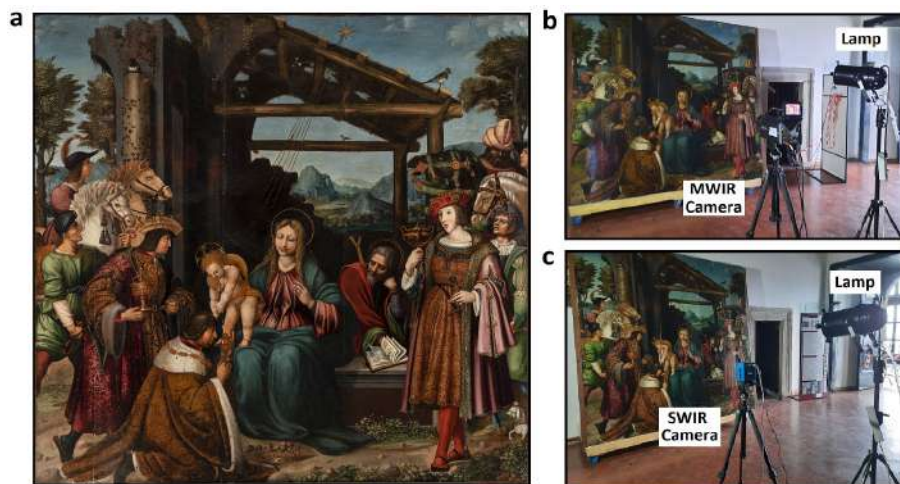
Fig. 1 Picture of the painting (a) and of the experimental set-up used for MWIR (b) and SWIR (c) analysis.

Analyzes in the MWIR region were conducted by applying an active thermography (AT) operative protocol. A halogen lamp (1000 W) with tunable power was used to apply a thermal pulse of 10 s on each investigated area of the painting. Thermal frames achieved during and after heating were recorded for 120 s with a frame rate of 10 Hz using a MWIR camera FLIR X6580 sc with a cooled InSb detector mounting a 50 mm focal lens (spectral range 3.5–5 μm , FPA 640×512 pixels, IFOV 0.3 mrad and NETD ~ 20 mK at 25 °C). During the heating, the temperature increase was monitored to obtain a maximum $\Delta T = 3$ °C as uniform as possible on the investigated area of the painting. Analyzes in the SWIR region were conducted by infrared reflectography (IRR). A halogen lamp (1000 W) was used to illuminate the area of the painting investigated and infrared images were acquired using the SWIR camera XEVA 320 with InGaAs photodiode array detector mounting a 22 mm focal lens (spectral range 0.9–1.7 μm , FPA 320×256 pixels). In both analyses, the camera was placed at 0° (frontally) with respect to the in-

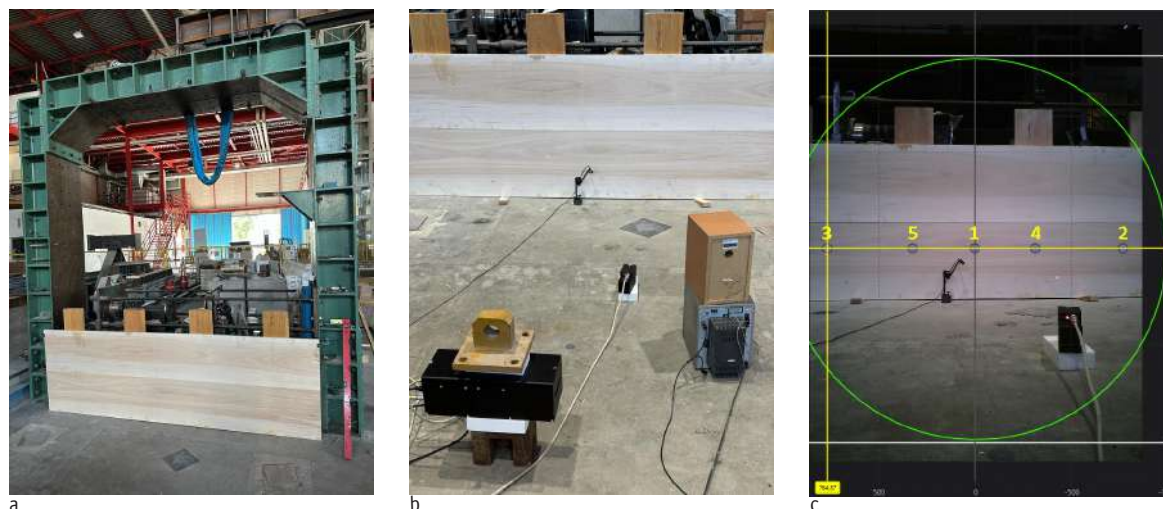
Fig. 3 a) Altarpiece simply supported, b) Altarpiece's replica restrained c) Tested points on the surface.

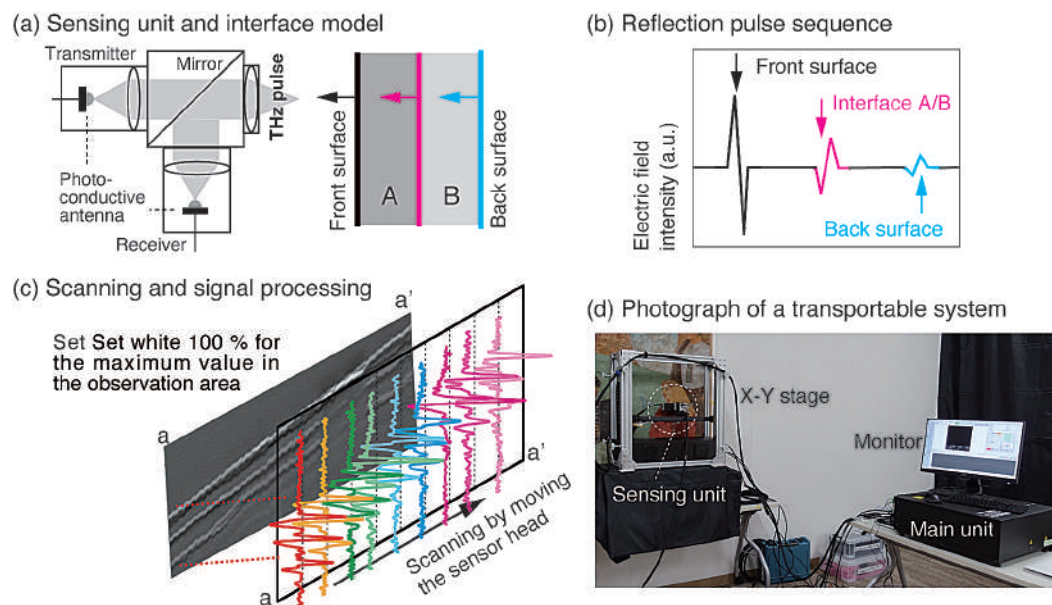
Fig. 1 Schematic diagram and photograph of THz-TDI.

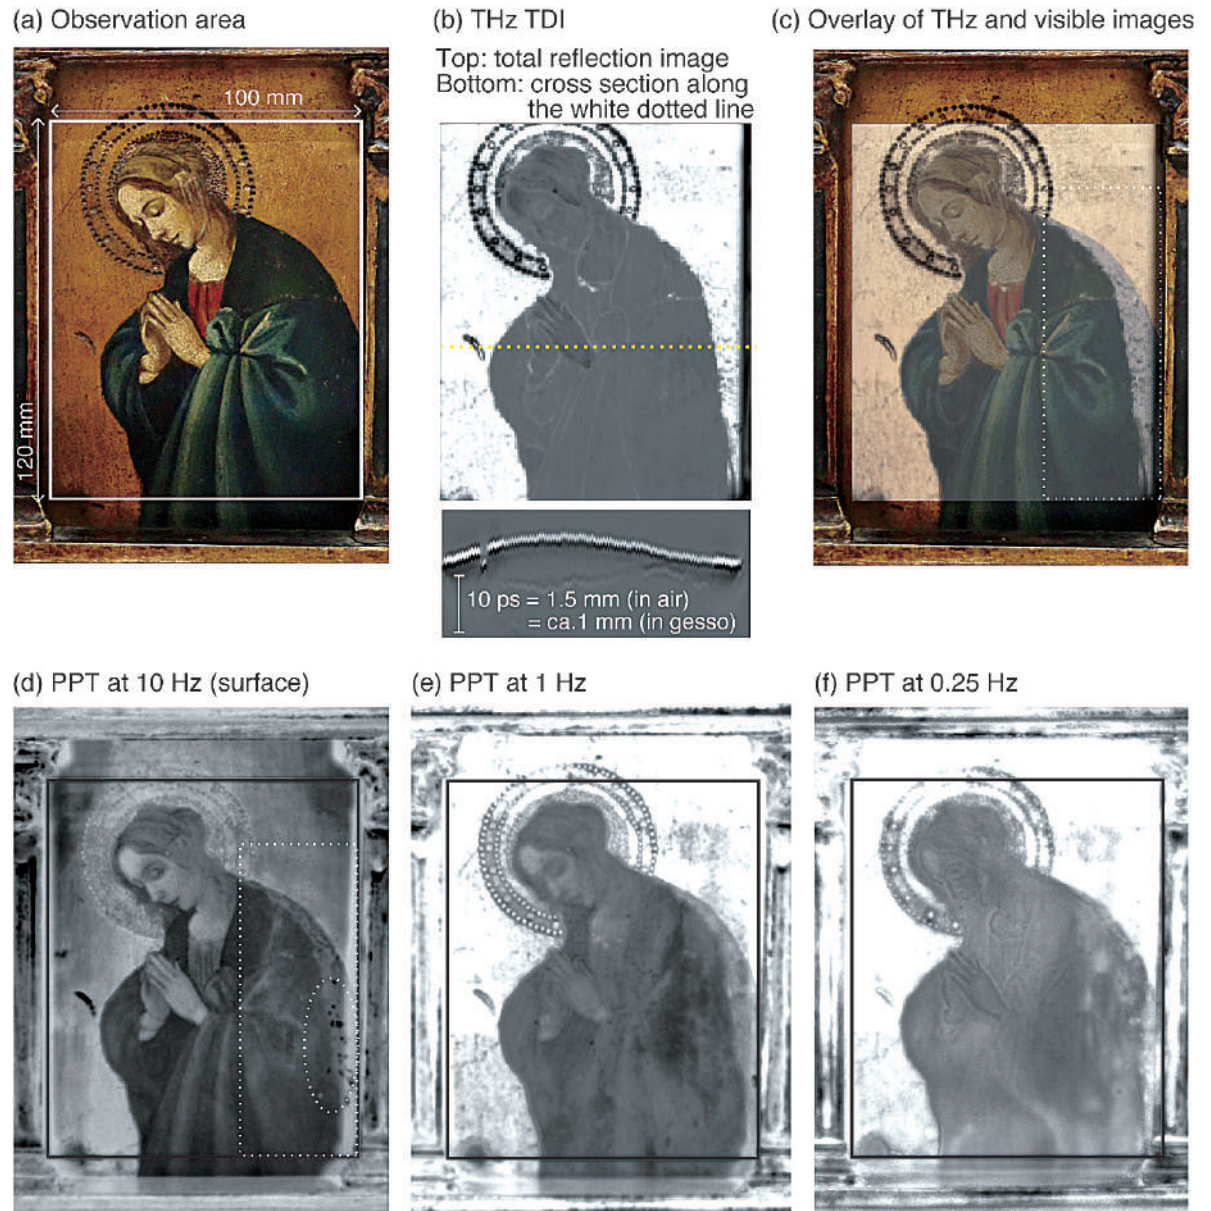
Fig. 4 Comparison of imaging results of a tempera panel painting using THz-TDI and PPT.

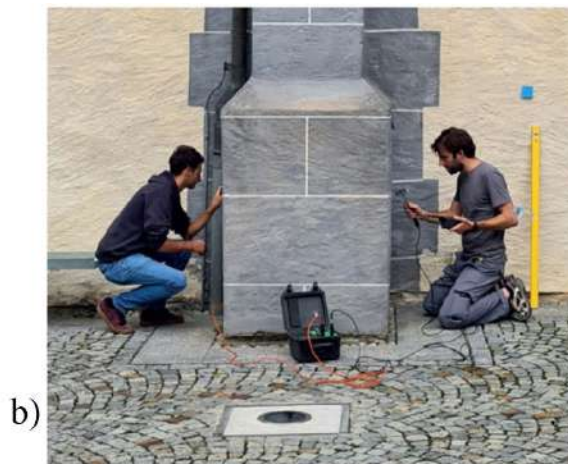
Fig. 2 diagnostic campaign: a) Flat jack test b) Sonic test.

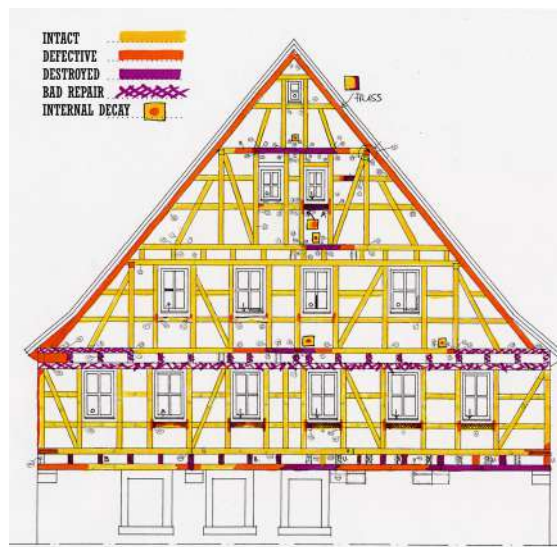
Fig. 4 Typical condition map showing the results of a one-day inspection of a historic facade in Southern Germany. The colours easily and quickly indicate, what needs to be done for restoring the building.

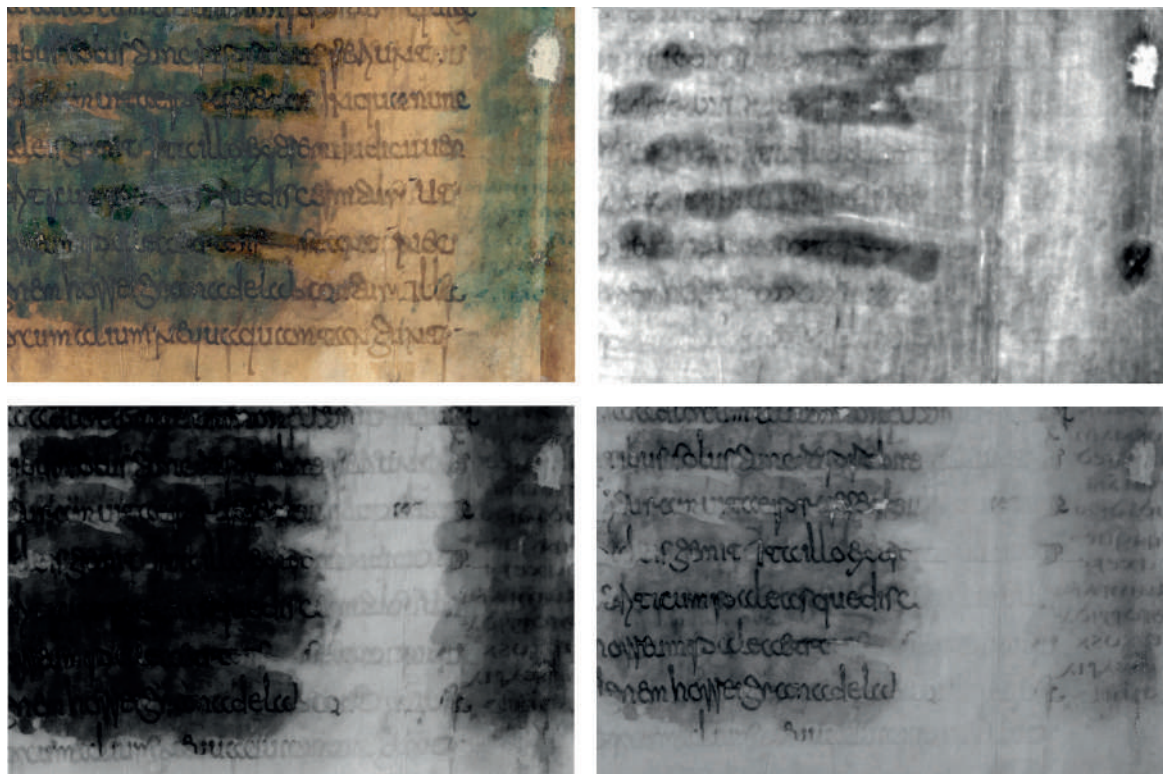
Fig. 3 From left to right; top: VIS and TQR imaging in the MWIR (3–5 μm). Bottom: IR reflectography with CMOS (0.8–1 μm) and InGaAs (0.9–1.7 μm) sensor. TQR is highly sensitive to surface materials.

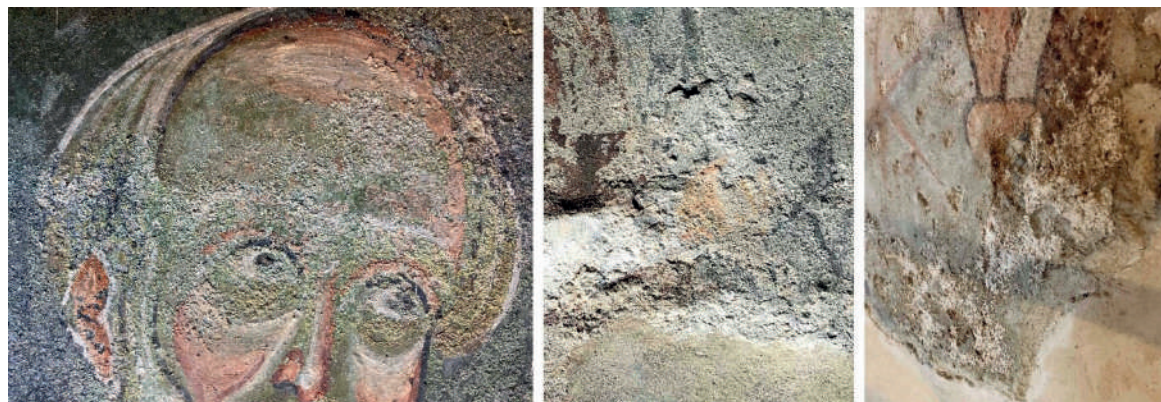
Fig. 1 Chapel of St. Eldradus (left and center) and Camera Stellata (right): details of the micro-flaking and decohesion of mortar caused by salts on three different areas.

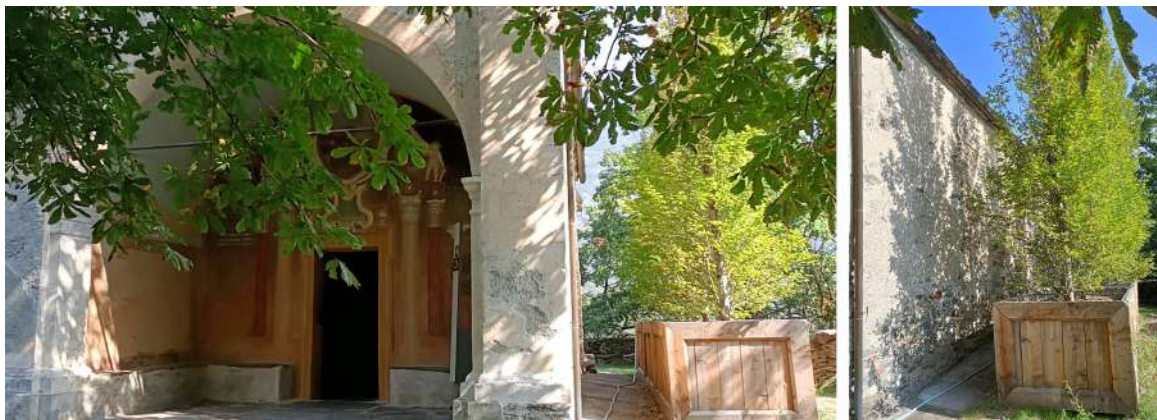
Fig. 2 Chapel of St. Eldradus
South wall. Natural thermal shield.

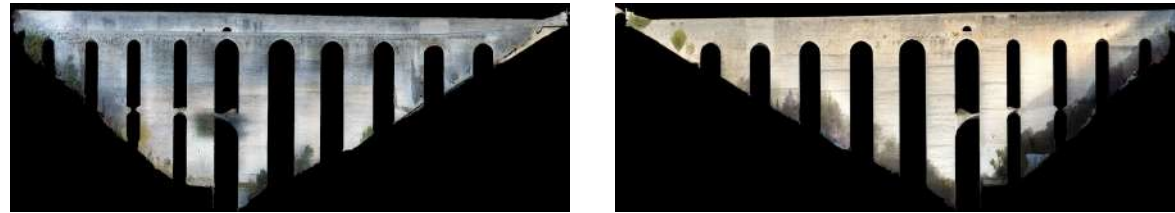
Fig. 5 Taxonomy of the cracks piers 4-8.

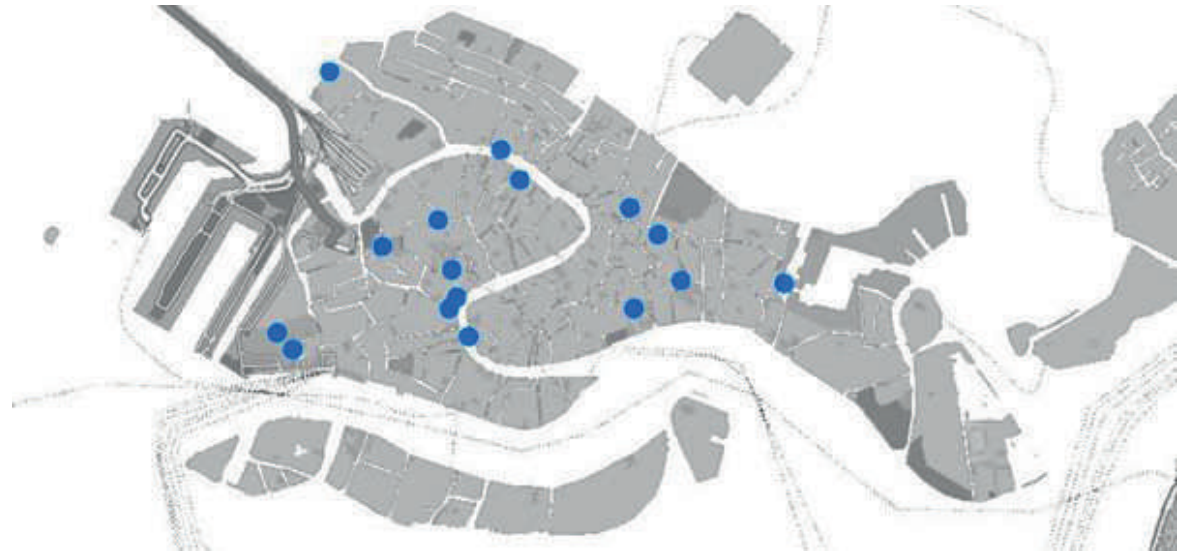
Fig. 1 Venice case studies of rising damp (Moisture Content [%] in the masonry).
